DEPARTMENT OF DEFENCE
DEFENCE SCIENCE AND TECHNOLOGY ORGANISATION
AERONAUTICAL RESEARCH LABORATORY

Technical Report 2

**FIELD EVALUATION OF SIX PROTECTIVE COATINGS APPLIED TO T-56
TUBINE BLADES AFTER 2000 HOURS OF ENGINE USE**

SUMMARY

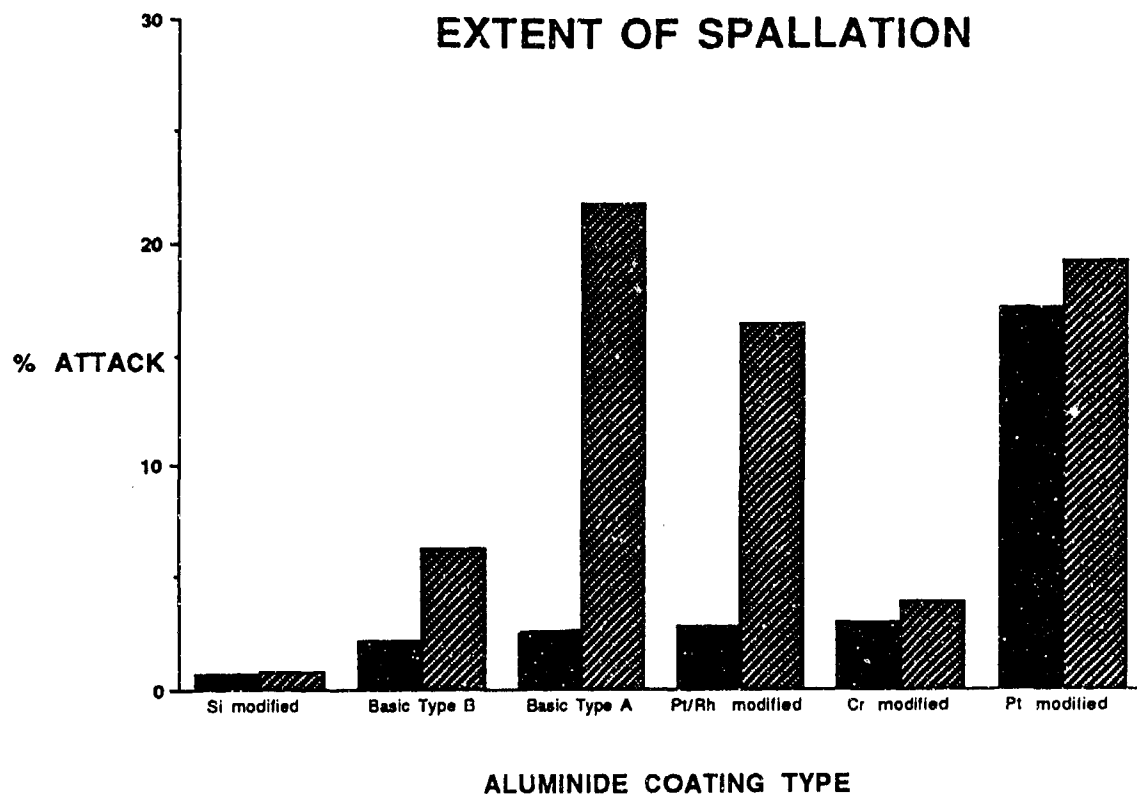
An estimate of surface spallation in the form of a bar chart for each of the coatings is illustrated in Figure 7. As presented in the previous report, several large variations in attack for identical coatings are obvious. It is important to mention the striking differences between the full and partly shaded bars for the platinum and platinum/rhodium modified aluminide coatings. However, these do not give a clear indication of the extent of spallation. The

Figure 7 Spallation chart of the concave side of the twelve turbine blades. These results were obtained through macroscopic evaluation.

(i) microscopic analyses indicated these blades had suffered from superficial spallation of the oxide scale with minimal ingress into the substrate

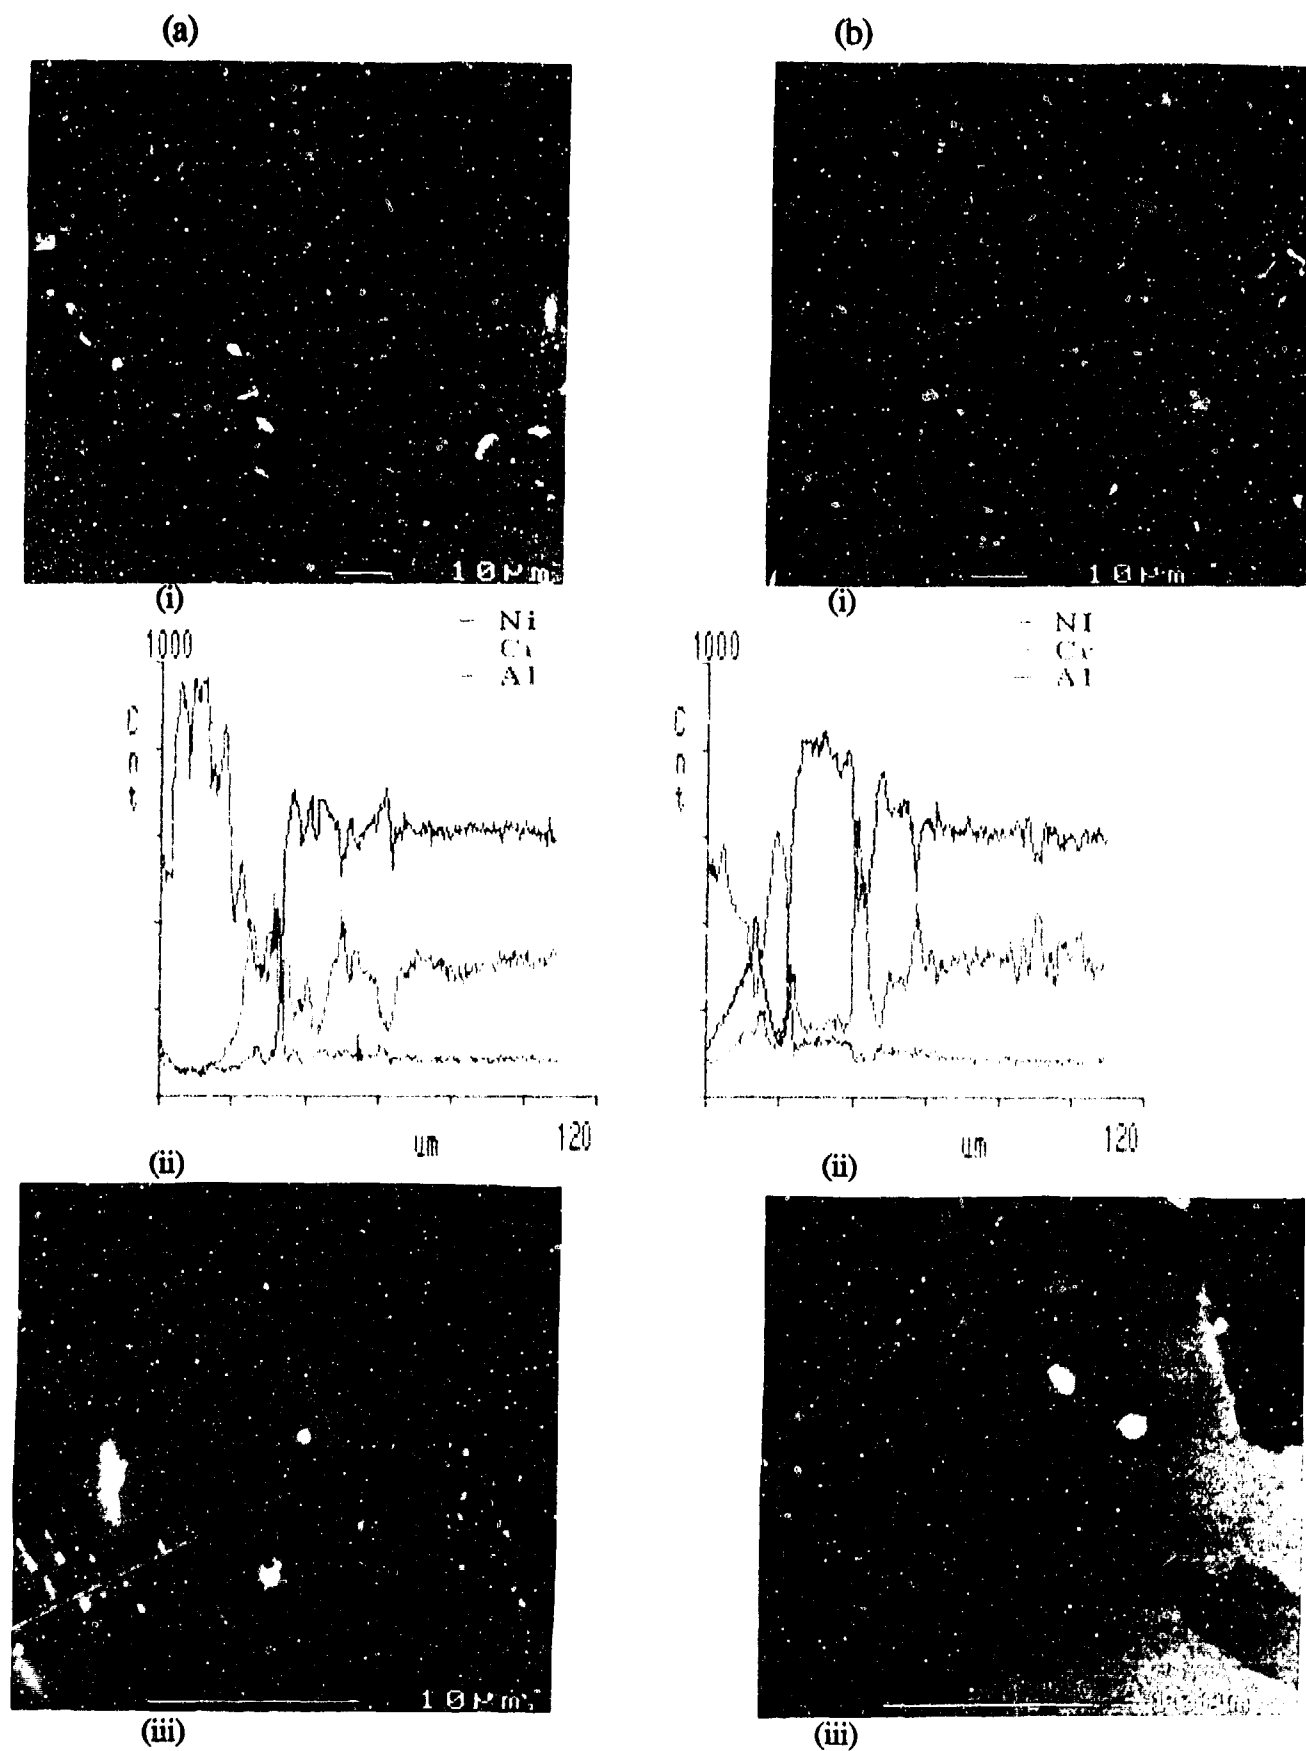
The oxide of the former coating (Figure 10a) consisted primarily of alumina (Al_2O_3) with smaller amounts of silicon, chromium and titanium. The presence of rutile (TiO_2) in the scale is to be expected given it has a very high free energy of formation, higher than that of chromia (Cr_2O_3). While the micrograph showed a lack of a diffusion zone, the qualitative line scans indicated otherwise; several chromium rich areas were apparent. The bright precipitates throughout the coating and substrate were found to be tantalum rich carbides. These bright precipitates were also present in the magnified view, the dark compounds being phosphorous/chromium rich and the grey needle-like compounds being, most probably, the chromium/molybdenum rich sigma phase.

A relatively thick oxide layer in the latter coating (Figure 10b) consisted of, in decreasing order, alumina, chromia and rutile. Other elements present in the oxide were silicon, nickel and phosphorous. The diffusion zone consisted mainly of chromium and titanium (greyish regions) and bright molybdenum and tantalum carbides (MoC , TaC). The remaining β -NiAl region, thinner than its original thickness, suggested that the coating had experienced some form of spallation or excessive oxide formation. The high magnification

Figure 10 Silicon-modified nickel aluminides (a) and (b) represented as micrographs at the concave leading edges (i) with corresponding line-scans (ii) and a magnified view of the corrosion front (iii).

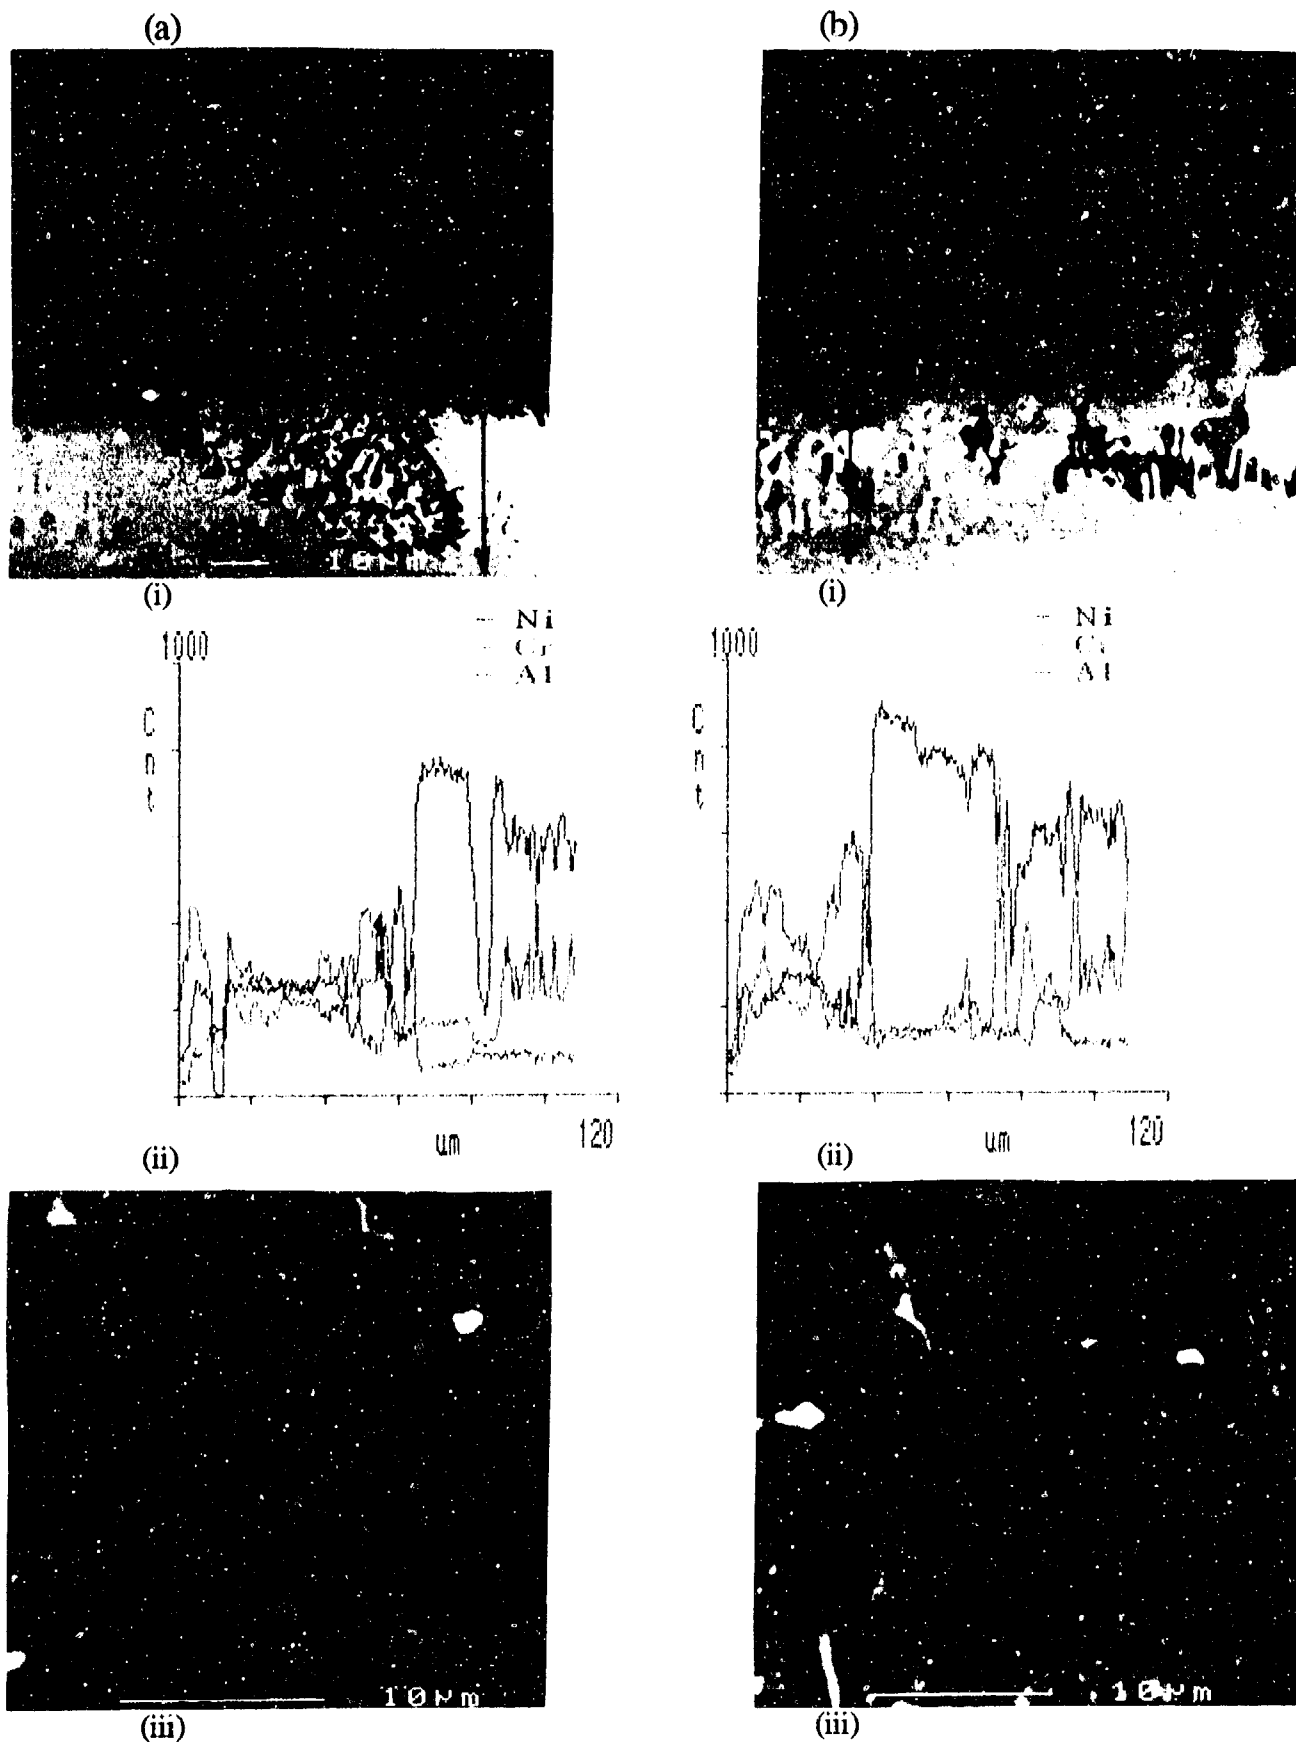
The type of attack, illustrated in Figure 11(a), is manifest as an extensive oxide layer with areas of intense needle-like penetrations into the substrate and occurring along the entire concave leading edge. These needles were found to be aluminium rich oxides. Evidence of a debonded oxide scale, seen as a sharp dip in the line scan, combined with porous areas in the oxide, signify that this blade is on the verge of complete catastrophic degradation. Qualitative results of the oxide scale suggested the outer oxide was predominantly alumina with an underlying oxide, in the vicinity of the advancing oxide front, a mixture of chromia and nickel oxide. The mere fact that nickel oxide was abundant in the oxide scale indicated that the coating was no longer offering any protection. Large bright precipitates were mainly niobium and tantalum rich carbides (NbC, MoC). The magnified micrograph (Figure 11a) shows one of the indicators for hot corrosion attack, namely chromium-sulfide particles, present as small dark specks.

Alternatively, the other Aluminide B coated blade of Figure 11(b), although suffering from moderate oxidation in certain areas, appeared well protected from further attack. It should be noted that the area shown in Figure 11(b) was not representative of the leading edge but from another area that had suffered the maximum degree of attack. On the whole, this coating appeared to be in very good order. The oxide scale, as in the previous blade, consisted mainly of alumina, chromia and nickel oxide. Two types of grains, distinguished by differences in their grey contrast, were evident in the region between the diffusion zone and oxide scale. Both grains were β -NiAl with the lighter shaded grains containing a moderate percentage of chromium. In addition, the complex diffusion zone illustrated a three zone region. The darkest areas were mainly NiAl/chromium compounds; the lighter precipitates were mainly a chromium base containing additions of refractory elements such as molybdenum and tungsten. The brightest areas were tantalum and titanium carbides. Although the magnified view of this coating showed quite extensive oxidation, it was only localised in a small area on the concave face. Minimal amounts of sulfide particles were located.

Figure 11 Basic nickel aluminides {Type A} - (a) and (b) represented as micrographs at the concave leading edges (i) with corresponding line-scans (ii) and a magnified view of the corrosion front (iii).

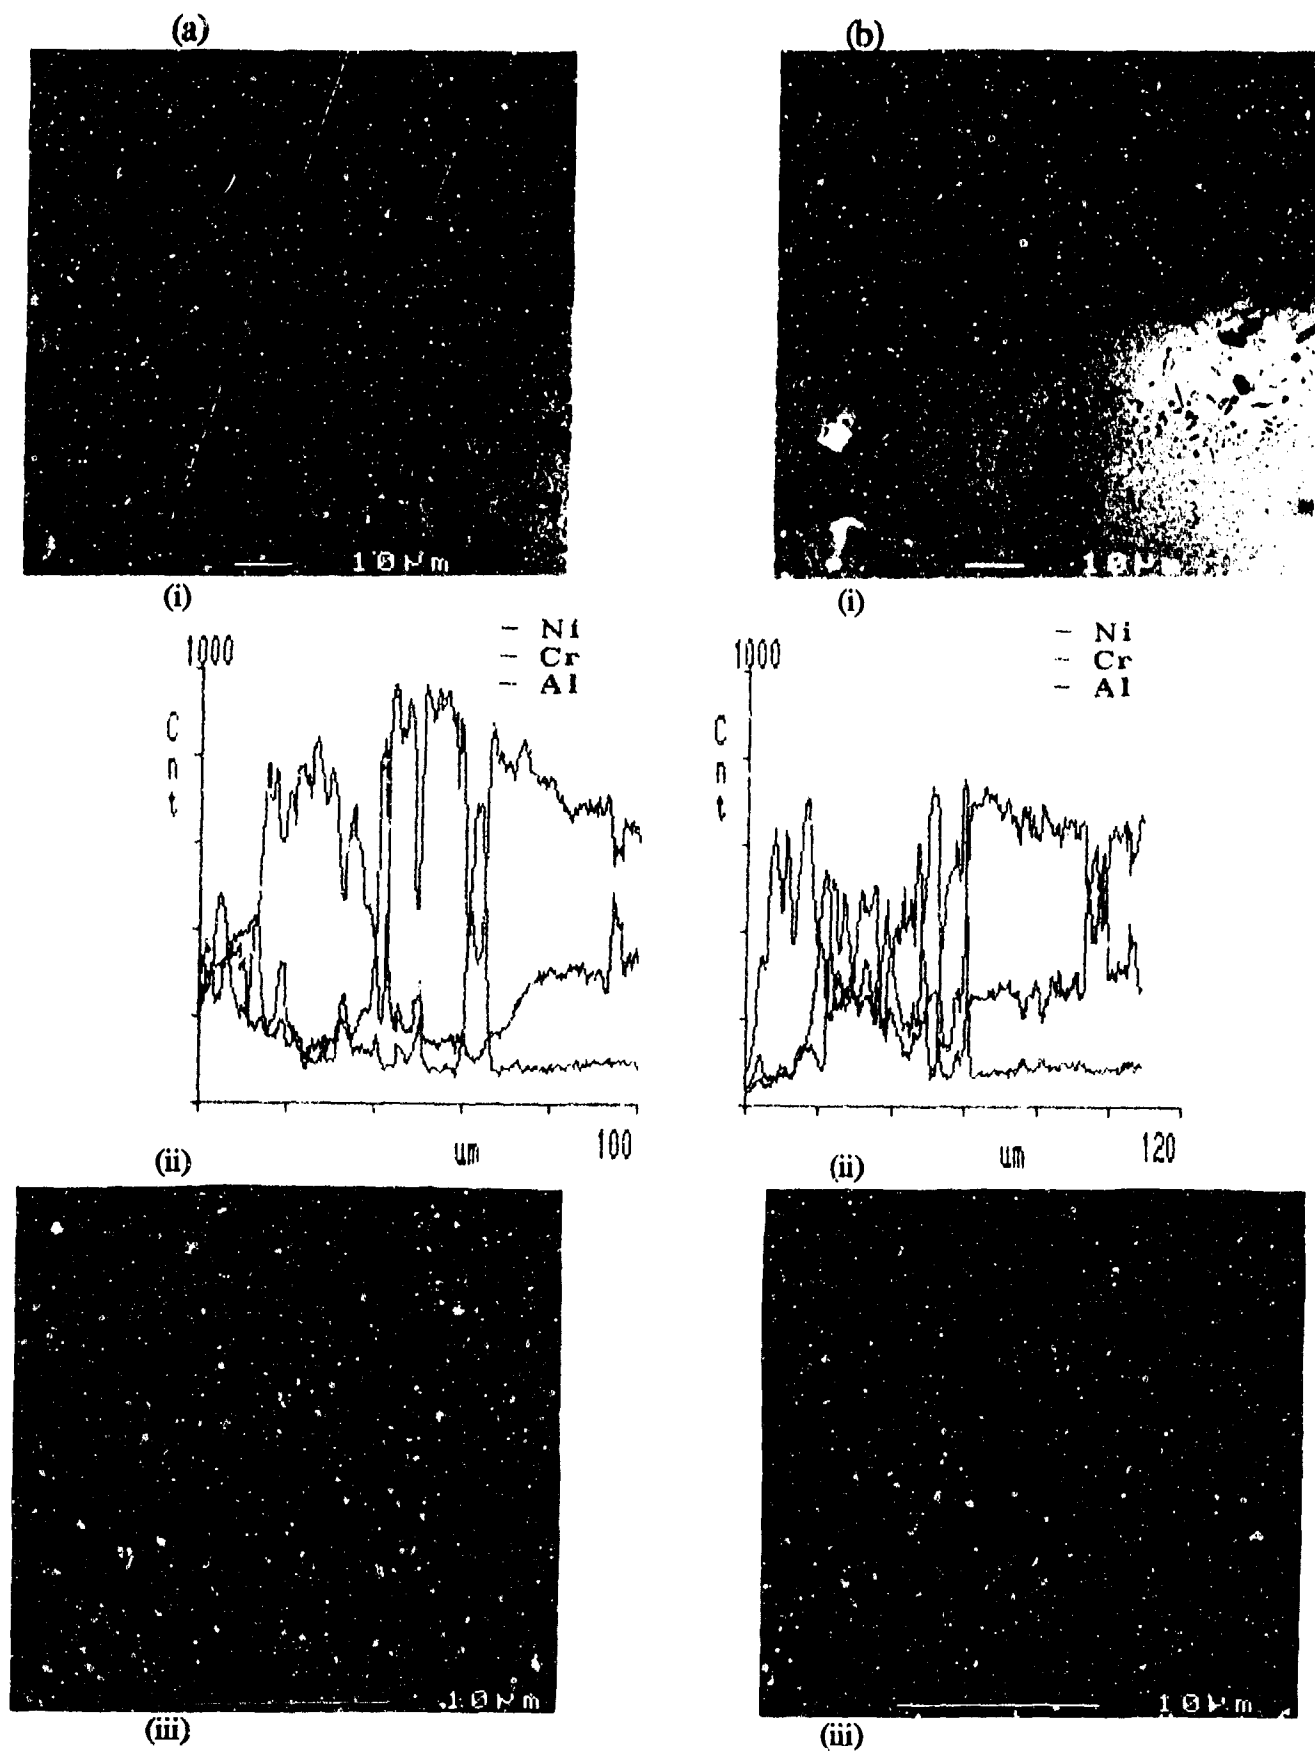
The microstructure of Figure 12(b), although demonstrating a thinner oxide scale, was very similar to the previous blade. Several large bright tungsten and tantalum rich carbides were evident in the depleted diffusion zone. If readily oxidised, these carbides can have an adverse effect upon resistance to hot corrosion [11]. Thus, it is of prime importance to ensure these refractory elements are restricted in their movement towards the surface otherwise volatile oxides may form. A closer view of the advancing corrosion front provided evidence of sulfur rich particles surrounded by chromia and alumina. The microstructure of this coating can be summarised in the following manner: large blocky precipitates of alumina; small needle-like phases rich in chromia and smaller round particles, in the vicinity of the advancing corrosion front, of chromium sulfides.

Figure 12 Chromium-modified nickel aluminides (a) and (b) represented as micrographs at the concave leading edges (i) with corresponding line-scans (ii) and a magnified view of the corrosion front (iii).

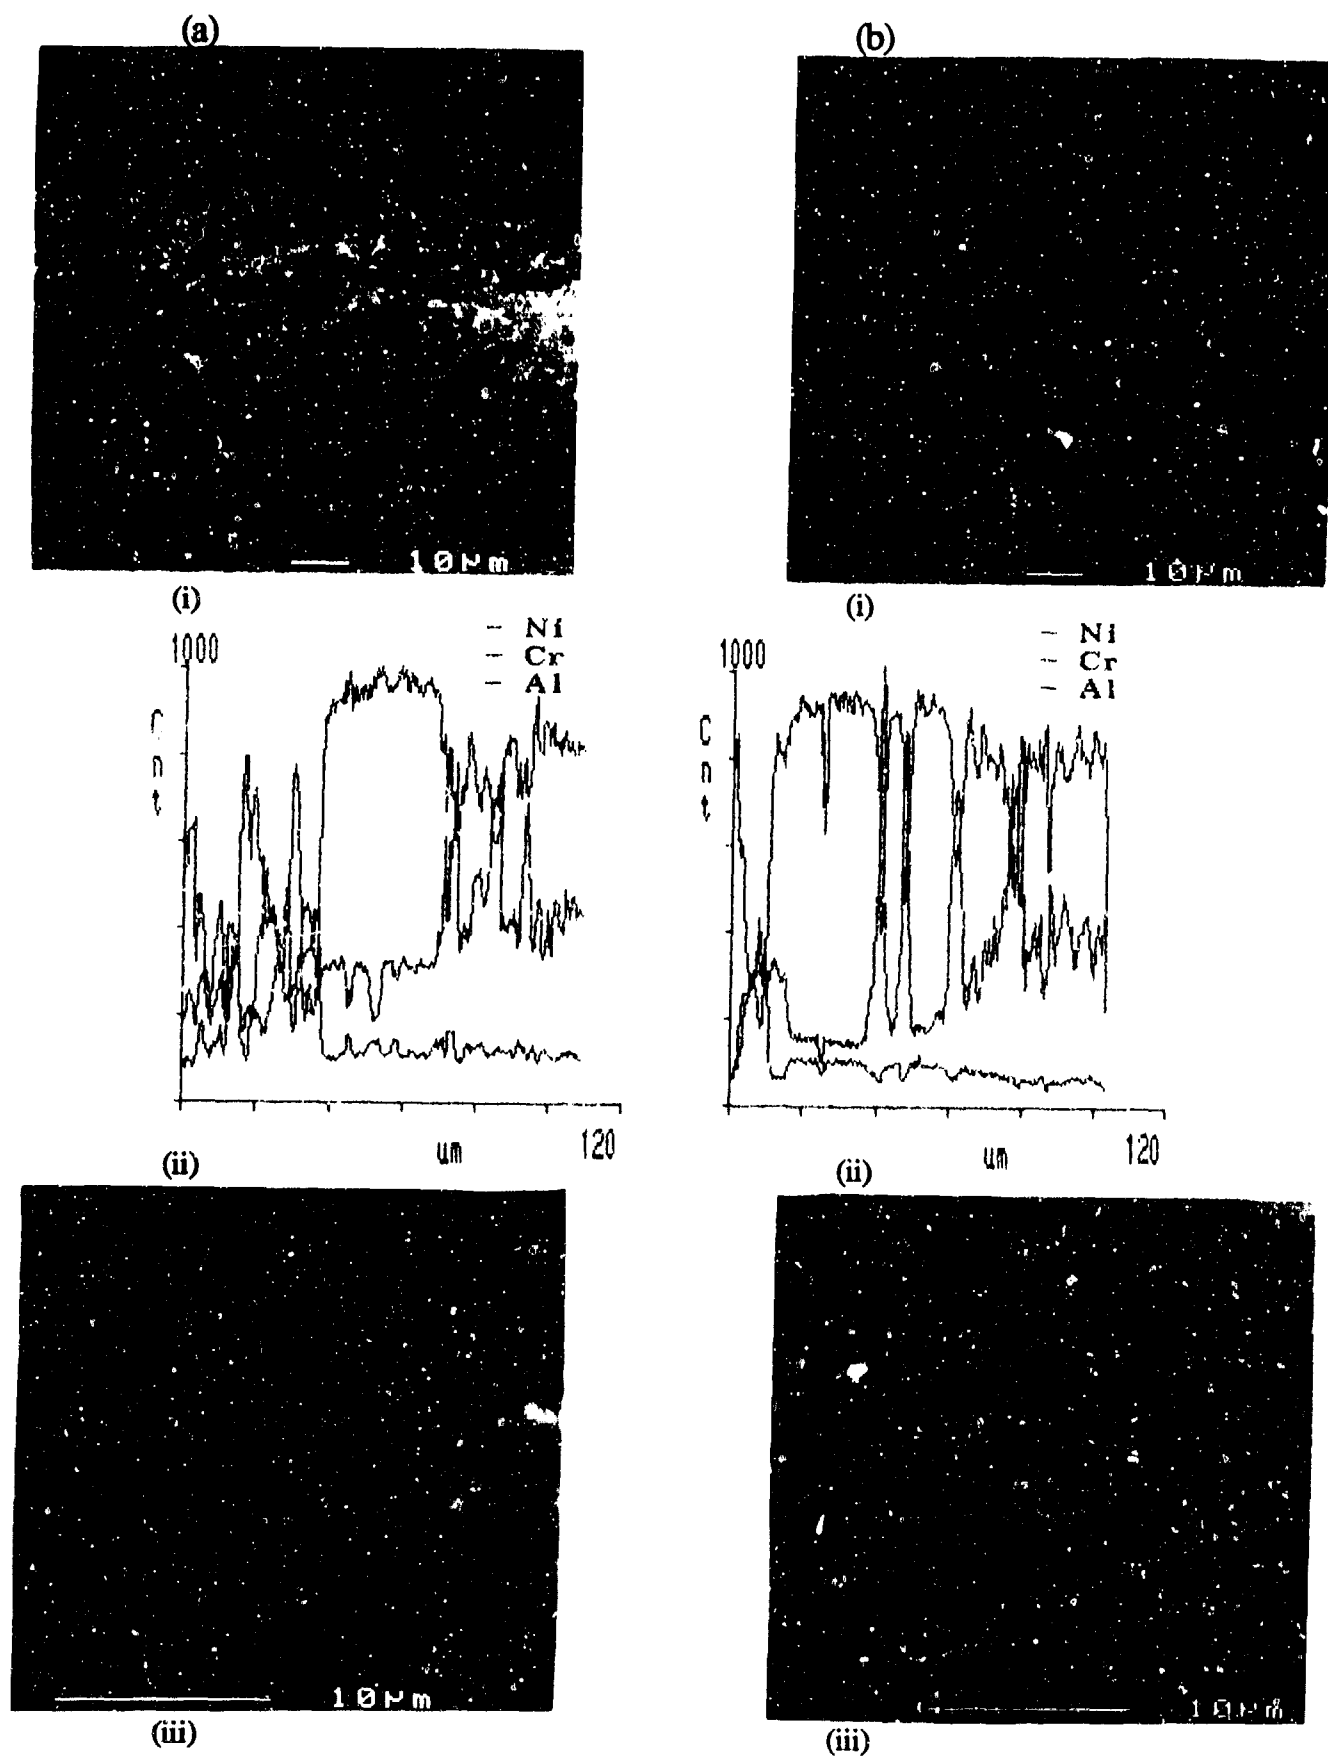
The outer oxide scale of the partially attacked blade illustrated in Figure 13(a) consisted of the common chromium, aluminium and nickel oxides in addition to small quantities of phosphorus and sodium. The amounts of these latter two elements diminished further toward the oxide/aluminide interface. Closer examination of the oxide in this coating revealed a number of bright specks that were found to be pure platinum metal. The aluminium, originally present in these compounds, may have diffused outwards into the oxide. The large bright precipitates adjacent to the diffusion zone were tantalum and niobium carbides ahead of the needle-like sigma phase rich in molybdenum and chromium. This deleterious phase is also shown in greater detail in Figure 16(a). This high magnification image of the corrosion front also depicts small areas of sulfide penetration. However, the surface degradation here is attributed mainly to high temperature oxidation.

Figure 13 Platinum-modified nickel aluminides (a) and (b) represented as micrographs at the concave leading edges (i) with corresponding line-scans (ii) and a magnified view of the corrosion front (iii).

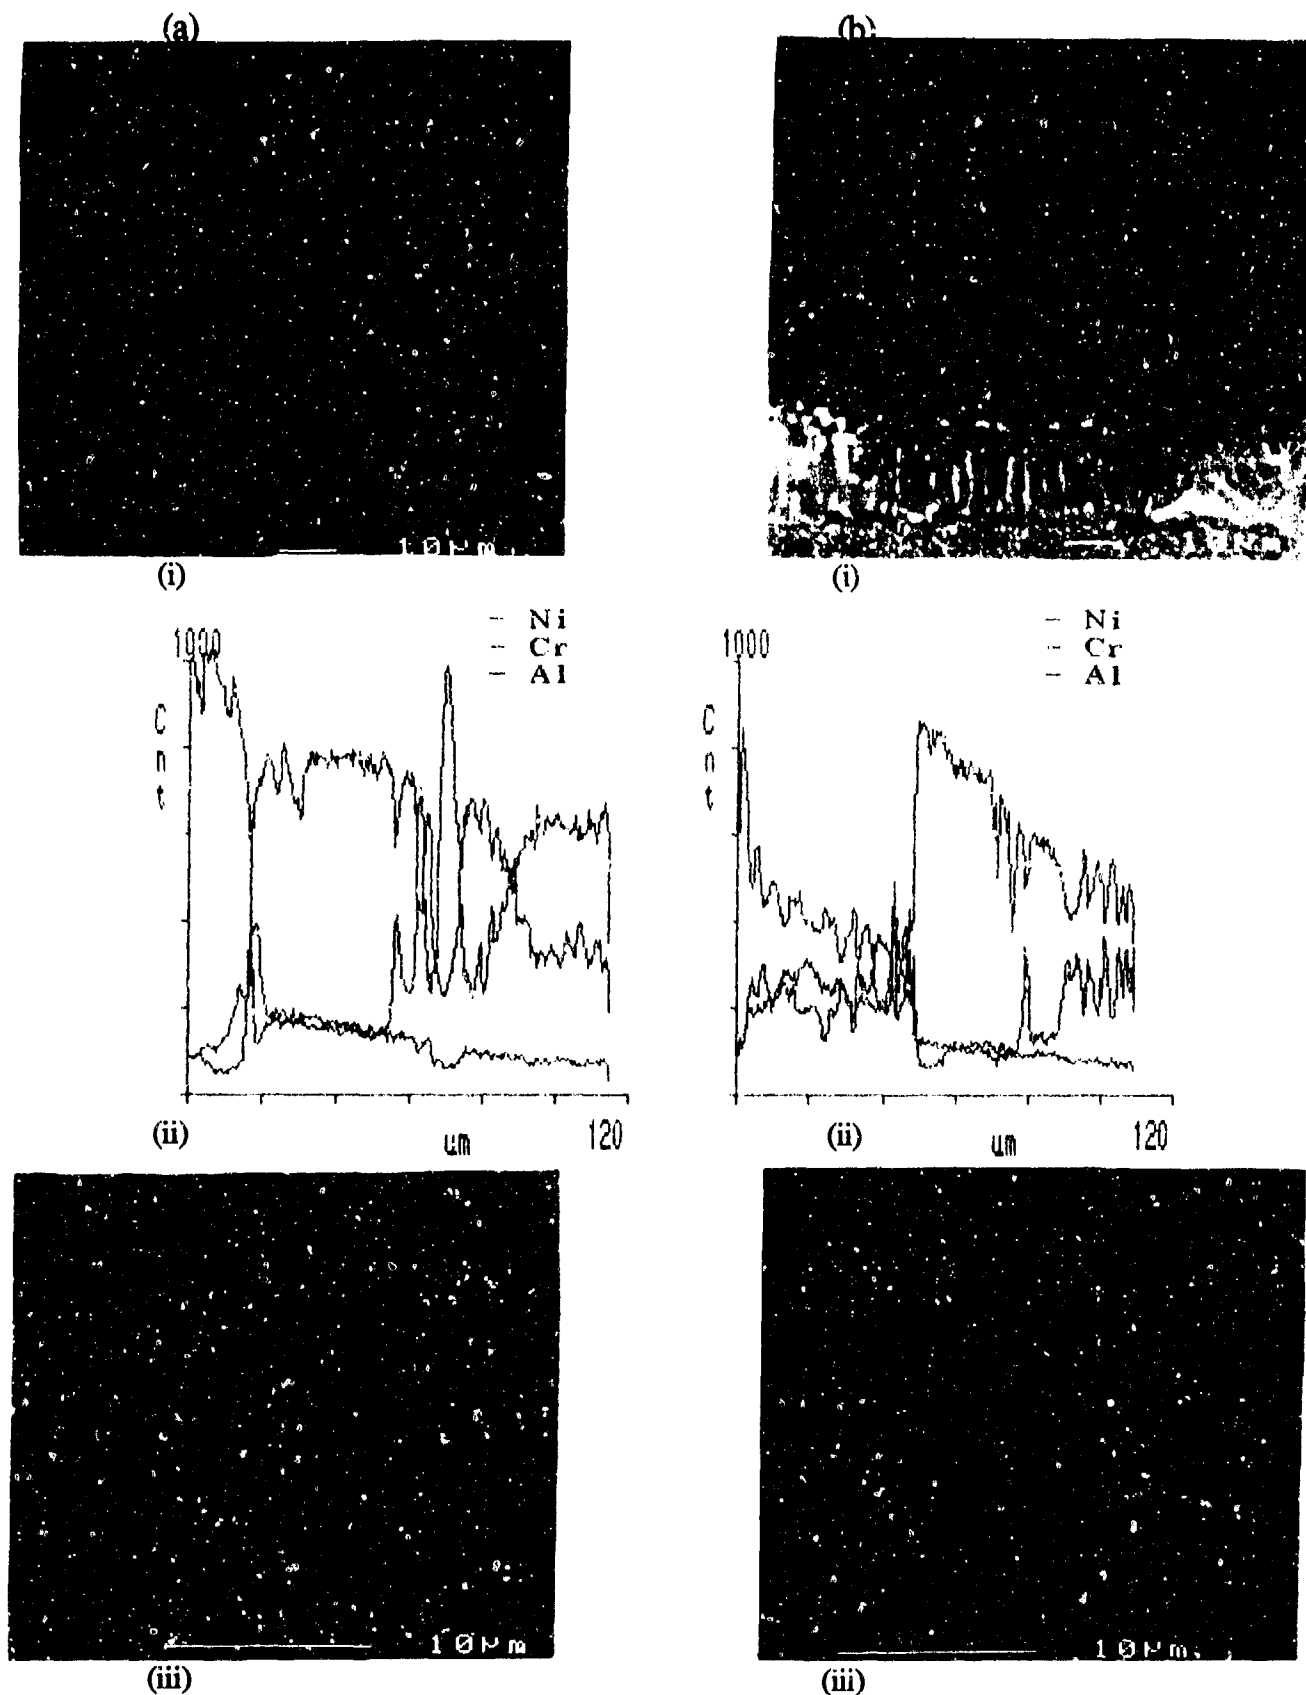
Extensive attack was evident along most of the concave face often reaching to the substrate. A typical microstructure of an area near the leading edge on the concave face is shown in Figure 14(b) indicating severe oxidation and hot corrosion. Finger-like penetrations on the right side of the micrograph are typical of Type I (HTHC). The oxide was predominantly alumina near the surface with chromia more abundant further in towards the oxide/coating interface. X-ray linescans also suggest that nickel oxide was present. Likewise, porosity of the oxide was evident. In the diffusion zone bright tantalum and tungsten carbides were noted; greyish chromium/molybdenum rich precipitates and the darkish α -chromium phase. A close analysis of the corrosion front indicated the presence of chromium sulfides represented as small dark circular spots.

Figure 14 Platinum/rhodium-modified nickel aluminide (a) and a basic nickel aluminide {Type B} - (b) represented as micrographs at the concave leading edges (i) with corresponding line-scans (ii) and a magnified view of the corrosion front (iii).
